Gothic Revival

Heritage restoration of 1860's home revealed deficiencies and structural issues

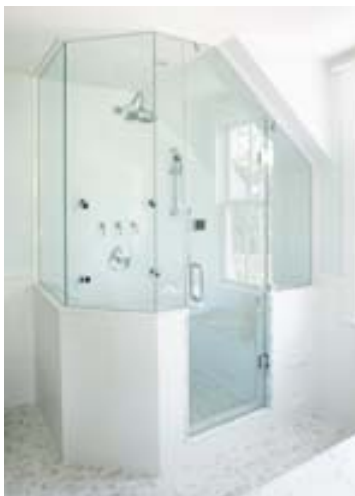
Amenities, such as on-demand hot water, were added to modernize the home.

Amenities such as a home audio-visual system, full networking, security features, and on-demand hot water system and heat recovery ventilators were added in order to bring the house's function up to modern standards.
